Analysis of coatings on bridges and tunnels &
health risk analysis before repair
Monitoring of corrosion inhibitors in concrete

Philippe Legros (OCAS)

Bridge and tunnel inspection in Brussels

Bridges inspection in Brussels

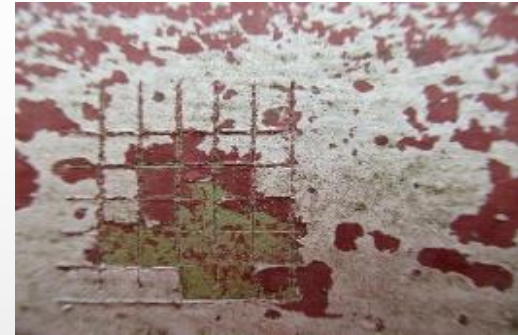
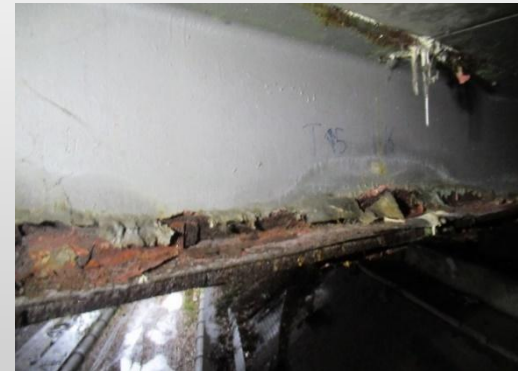
- Inspection & paint samples taken
- **Paint analysis**: composition and hazardous compounds, incl. CMR substances, Pb, Cr(VI), Polycyclic Aromatic Hydrocarbons (PAHs), PolyChloroBiphenyl (PCB)
- **Dust analysis** collected in various areas in tunnels
- **Evaluation of coating degradation** (blistering, rusting, cracking, flaking according to rating scheme)

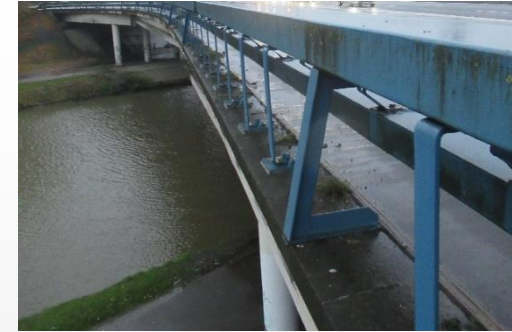
- Bridge Maintenance & Repair: **the tasks**

- Coordinated the project and helped with the samplings and steel analyses. The analysis of asbestos was subcontracted to an accredited company.

- Inspection of coatings by a accredited inspector, including on-site tests (thickness, adhesion, porosity, ...) and paint samplings for analysis.

- Analyses of the paint flakes collected by Endures focusing on carcinogenic, mutagenic, or toxic for reproduction (CMR) substances, heavy metals analysis (in particular Pb) and Polycyclic Aromatic Hydrocarbons (PAHs) determination. Risk assessment before starting any maintenance work on bridges.

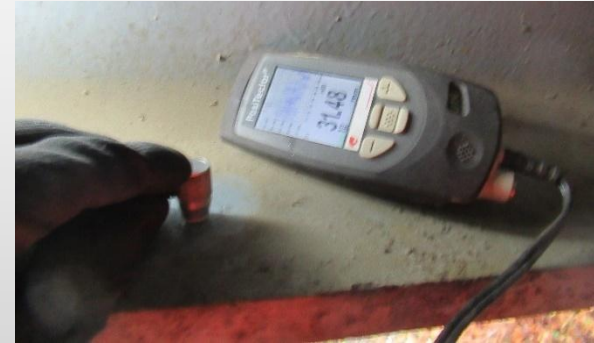
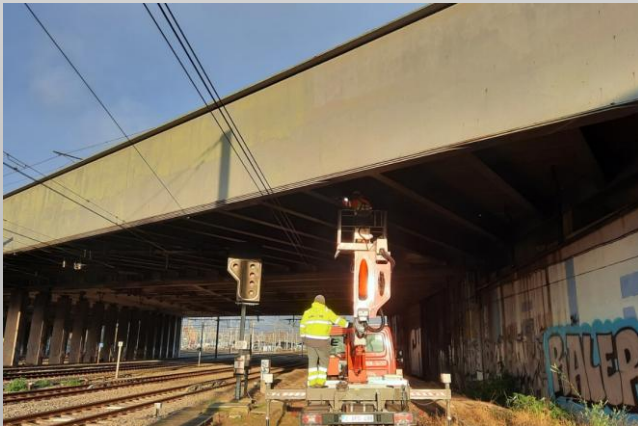
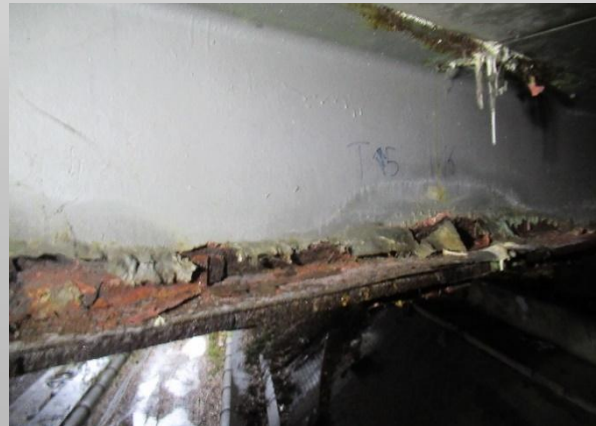
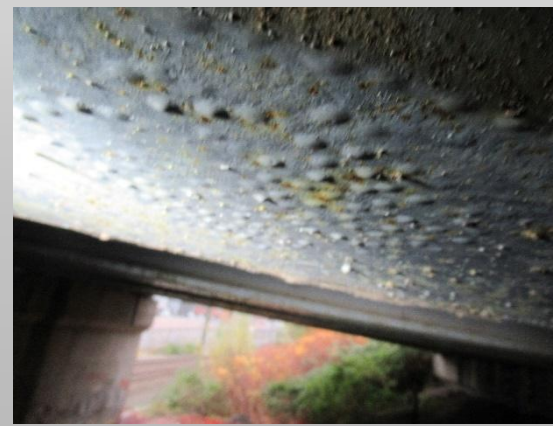
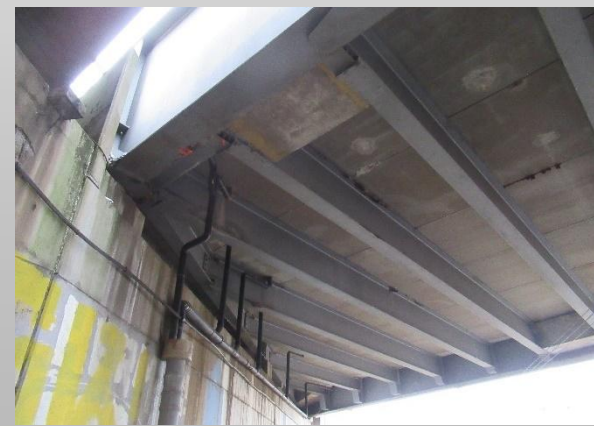
- Steel:
 - Thickness measurements by ultrasound
 - according to ISO 16809
 - Visual observation
 - Corrosion, defects
 - Steel analysis (S235, S335 grades)
 - Technical support of OCAS; steel grade and weldability

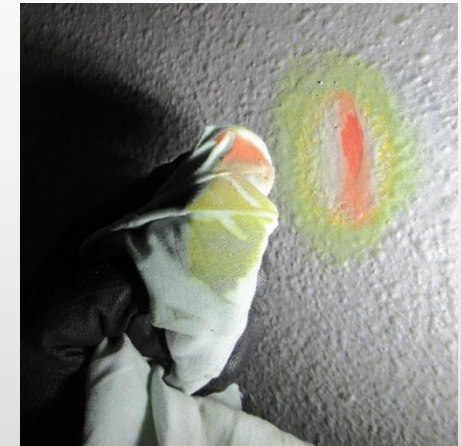
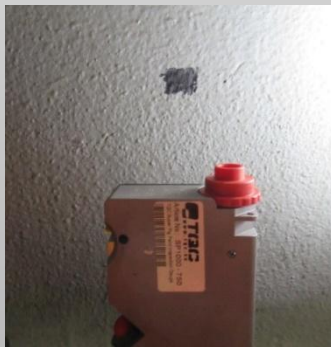
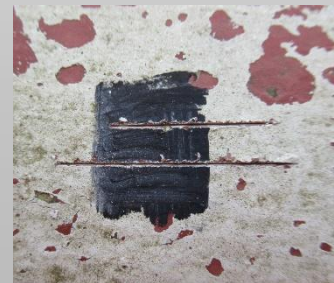
- Thickness measurements by Coating Thickness Gauge

- according to ISO 2808 7B.2
 - Average value of 15 measurements per sample

- Type of paints

- Paint system according to the resistance after solvent (MEK) test
 - Identification of the different layers of coating and corresponding thicknesses (PIG, Paint Inspection gauge)

PIG : épaisseur de chaque couche (micron)	
	A.02
Couleur	Epaisseur
Zinc	40
jaune	20
Rouge 1	60
Blanc 1	80
rouge 2	40
blanc 2	40
Total	280

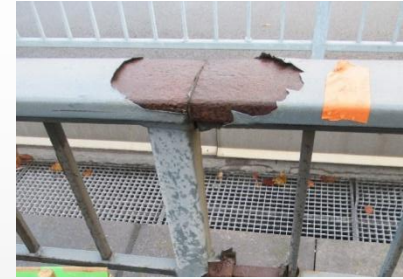
Class 1

- Evaluation of degradation of coatings

- Blistering, rusting, cracking, flaking according to rating scheme (ISO 4628-1 to 5)

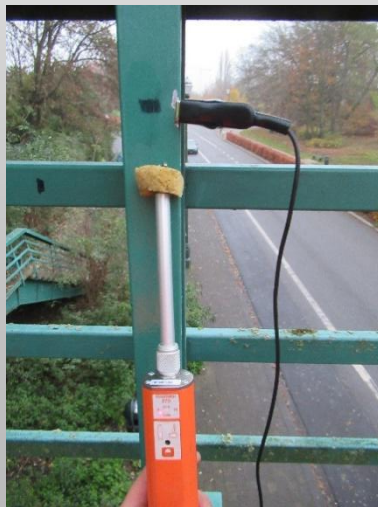
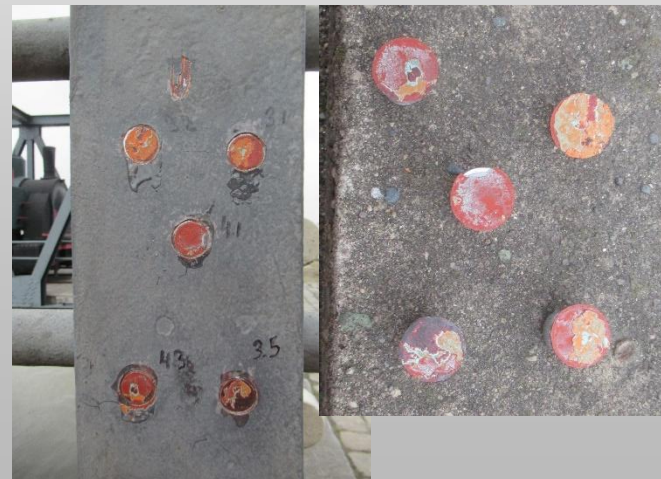
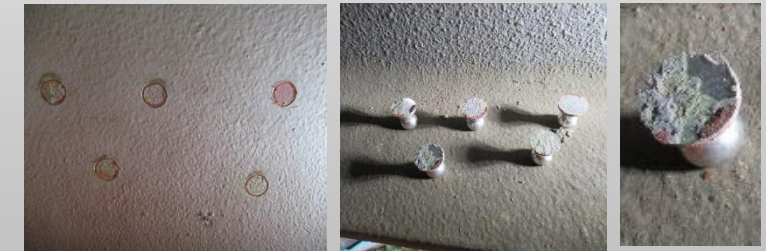
- Paint adhesion

- Cross-cut test (for paint thickness lower than 250 μm), ISO 12944
 - Pull-off test (adhesive, cohesive failure, %, rupture force), ISO 4624
 - Wet sponge porosity detection (ASTM D5612)

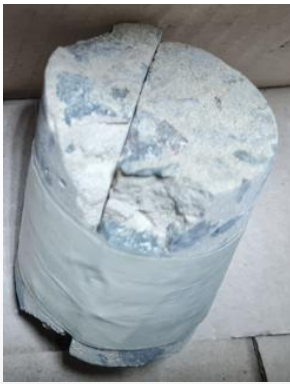
Monitoring of corrosion inhibitors in concrete

- The customer wanted to repair corroded concrete areas in different tunnels
 - Application of 2 different corrosion inhibitors to the concrete
 - The inhibitor would migrate a few cm (6-8 cm) to reach the steel to be protected.

- Ocas has developed a methodology based on FTIR analysis to monitor the migration of the inhibitors

- One inhibitor was better than the other (migration through the concrete, including the fire-resistant flocking)
